Division of Oil, Gas & Mining

Inspection Report

Minerals Regulatory Program

| Mine Name: SiO2 | Permit Number: M/045/0046 |

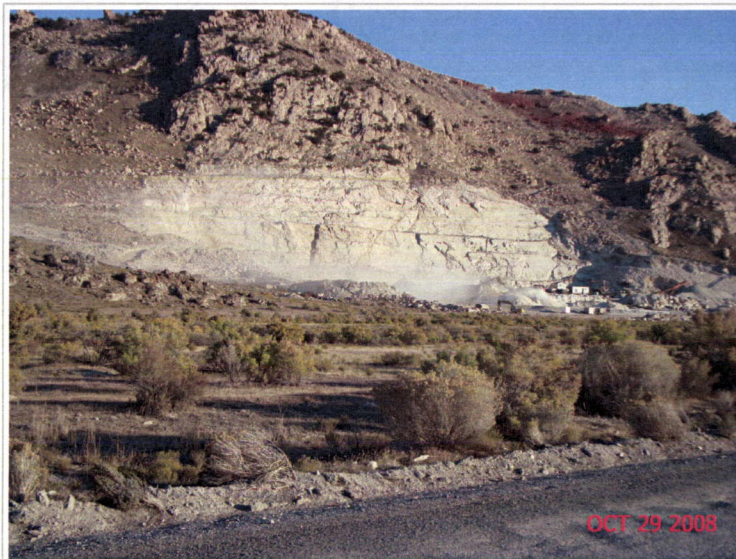
Inspection Summary: Disturbed area is compact. Highwall follows dip of bedding. At the time of the field inspection, there was considerable dust coming from the crusher. I informed the operator, that is was not acceptable, he noted that the water pump had just gone out. There was water tank and sprayer system in place for dust suppression. I suggested that he consider adding a backup pump to the system so he could continue to operator in the future when the primary pump goes out.

Dust from processing

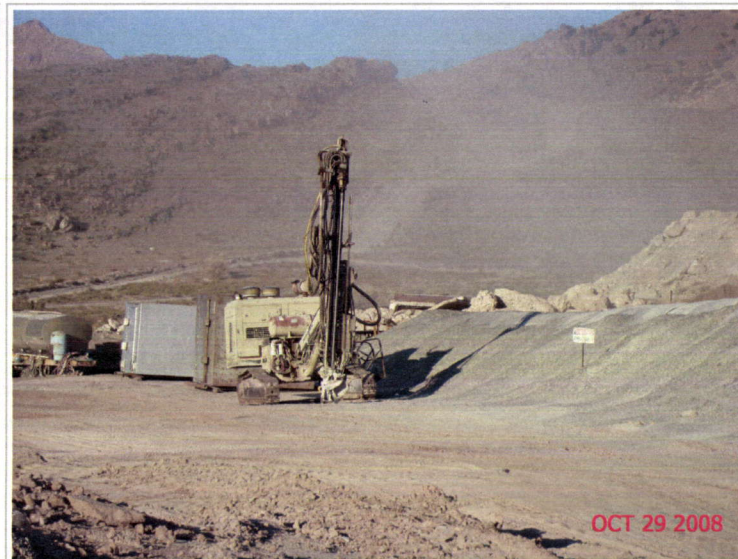
Drill Rig

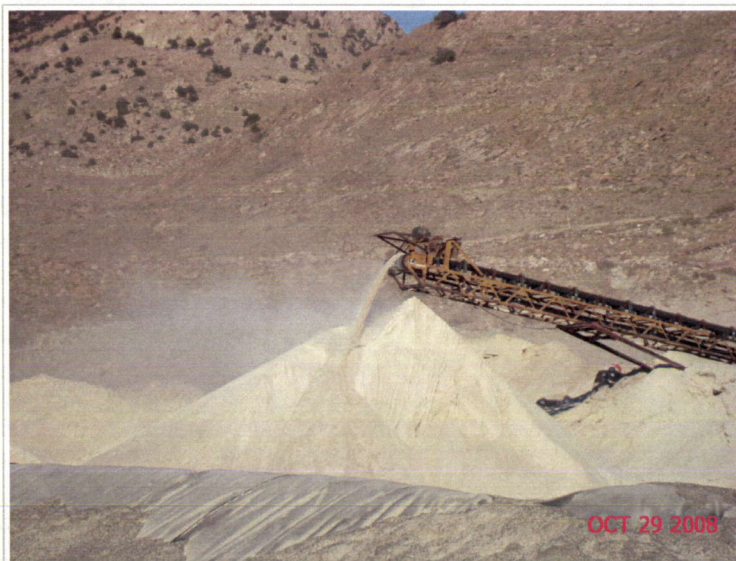
Close up view - Dust from processing

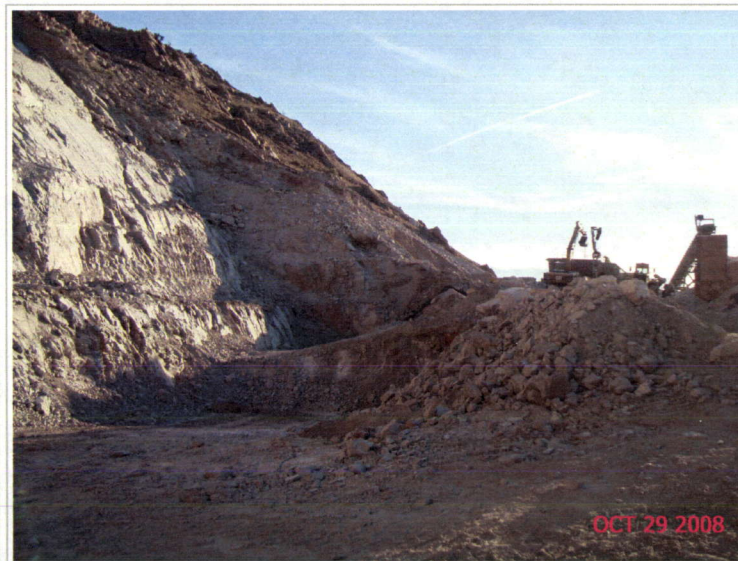
Pit Wall – Note Mine face is parallel to bedding
